PROGRESS REPORT

FOR THE CONSTRUCTION OF MBAA WATER PROJECT

2. Date of report: 15th September 2013

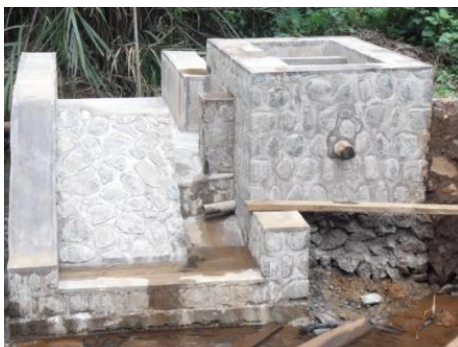
It has been completed at 98 percent level. Only plumbing and spill weir control device is pending completion. The strategic location of the sedimentation tank required the addition of a dam wall to the stream intake on either side to raise the water level. Thus the dam wall is completed at 70 percent level. It is constructed of dry stonemasonry (without mortar) and includes two wall leaves with a cavity in between to be filled with clay soil to make the wall impervious.

Front view

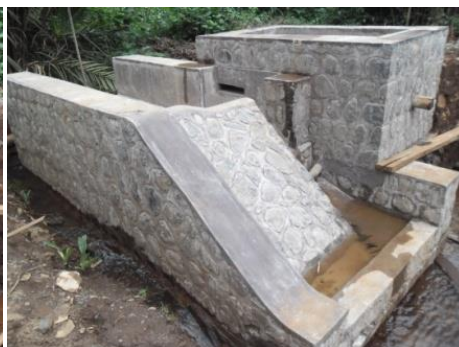
Left-Front view

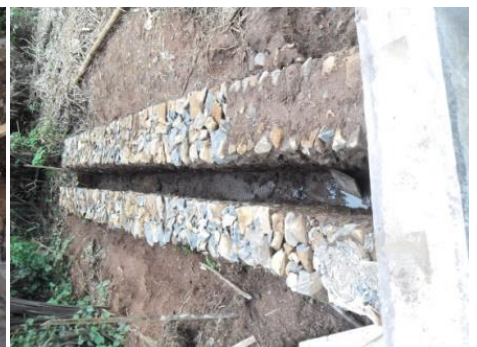
Intake dam wall

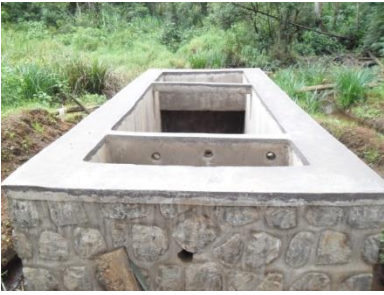
It has been completed at 99% level and pending only plumbing.

Inlet end view

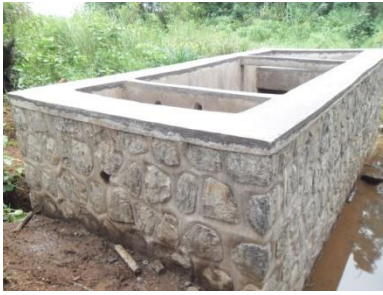
Inlet end-right view

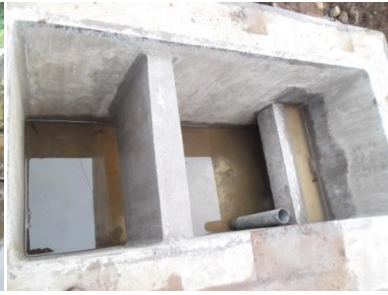
Interior of tank

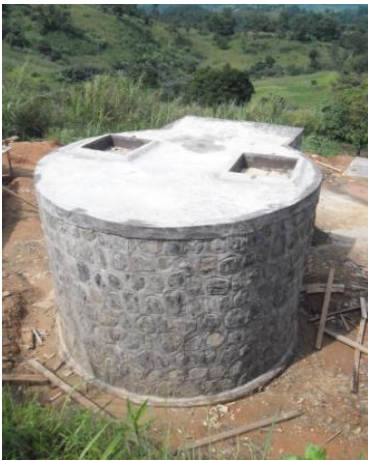
It has been completed to 96% percent level and pending only installation of door shutter, plumbing and placement of the gravel filter media.

Rear-Top views

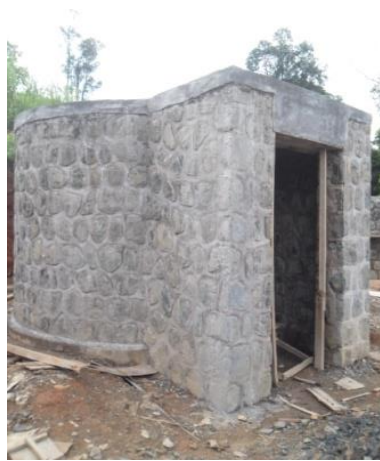
Front view

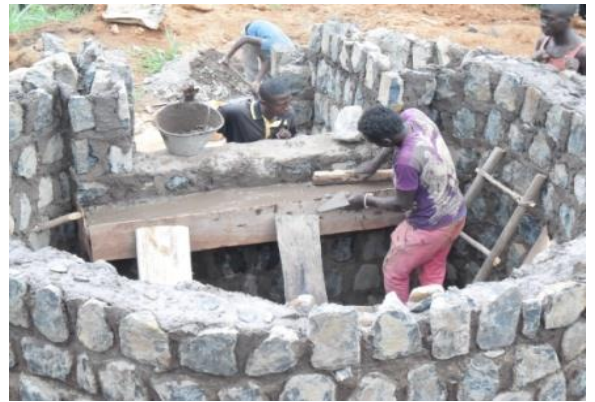
Interior view

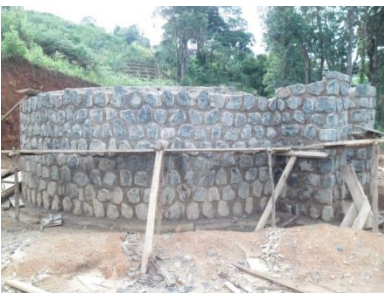
It has been completed at 70% level. Elements still to be constructed include plastering, pointing, roof slab, door shutter, plumbing and sand filter media.

Left View

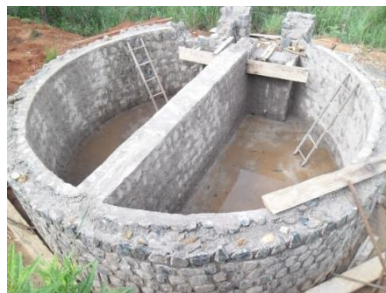
Top view

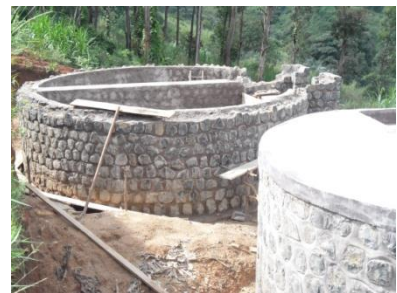
URF beside SSF tank

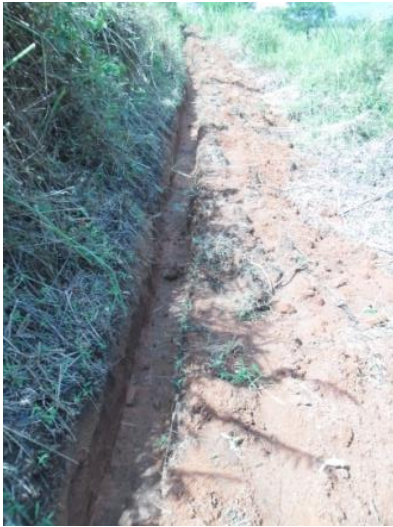
Soft sections of pipeline

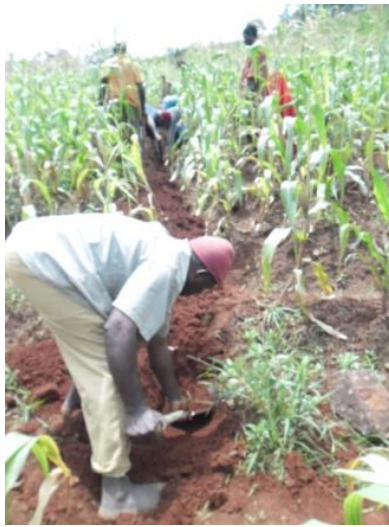
Excavation via maize farm

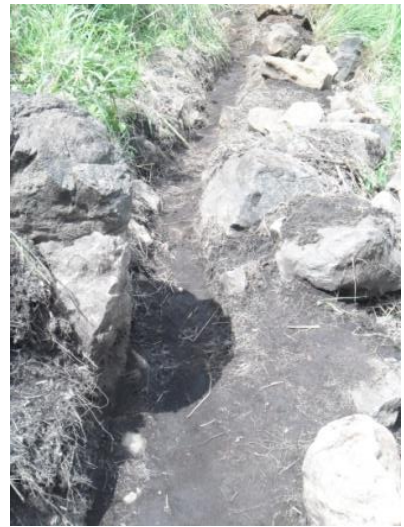
The excavation of trenches has been completed to 65% level. Work done is not up to the level that plumbing can commence. 300m of the pipeline is full of stones and thus making excavation process difficult. The community members are putting in their best and are only able to put in two days of work per week out of their daily economic and social activities.

Stony section

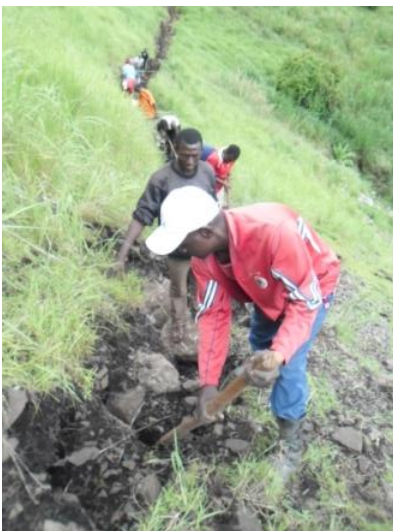
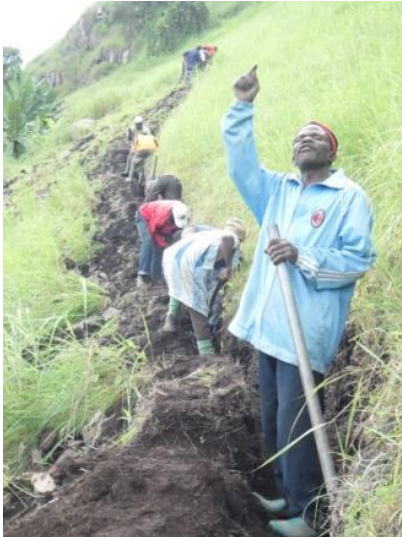
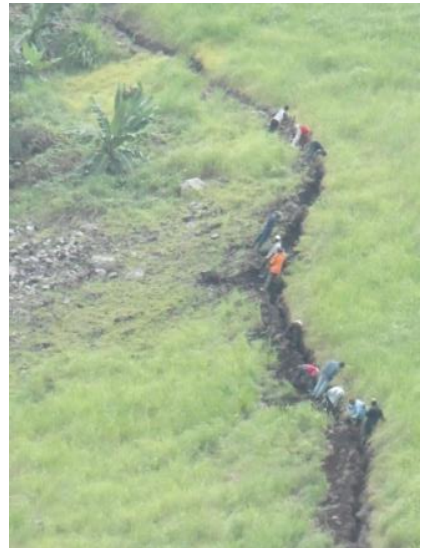
Community work-excavation of pipeline trenches through stony sections

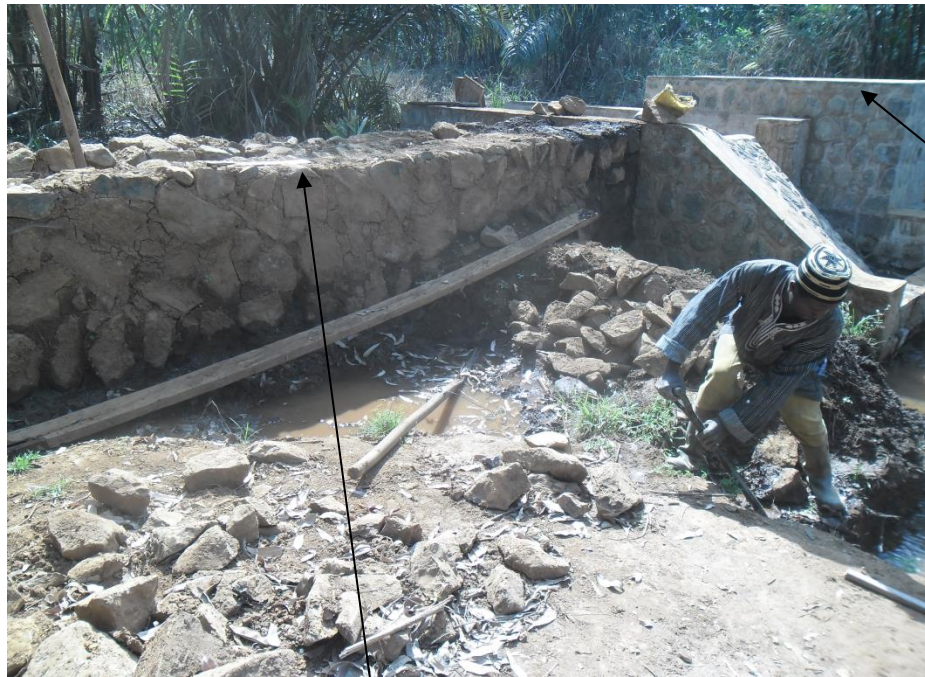
Mbaa Water Project Dam wall and catchment structure

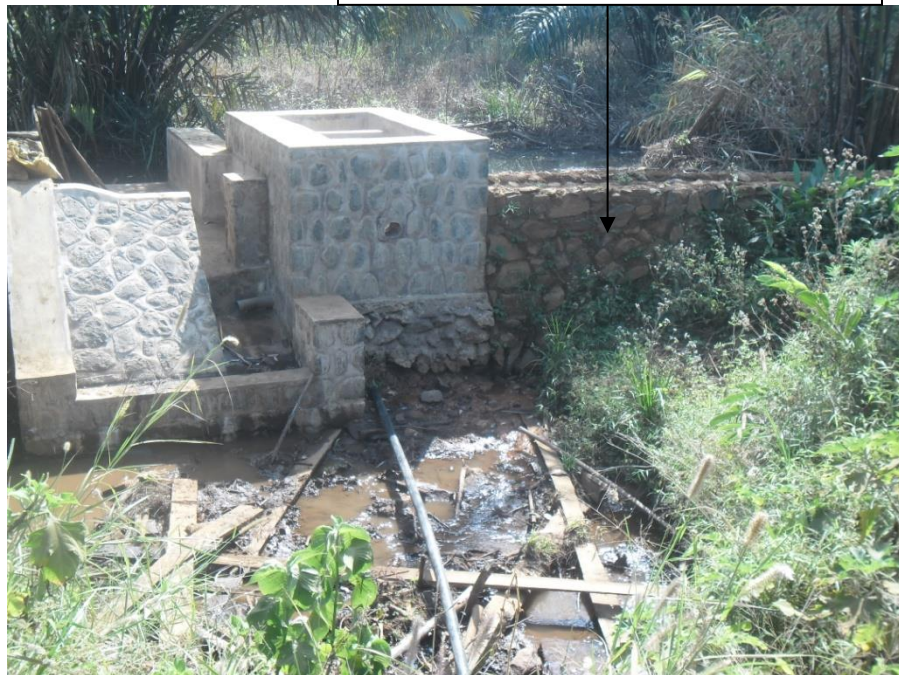
Stream
Intake

Dam wall built of mud mortar and stones
(Left wing)

Dam wall built of mud mortar and stones
(Right wing)
